Reducing disaster risk to life and livelihoods by evaluating the seismic safety of Kathmandu's historic urban infrastructure: enabling an interdisciplinary pilot

Abstract: Kathmandu's cities are exceptional architectural and artistic achievements, underpinned by centuries of seismic adaptation. They represent portals where heavens touch the earth and individuals commune with guiding deities; their tangible and intangible values promoting community cohesion. Kathmandu's skyline was dramatically altered by the 2015 Gorkha Earthquake as almost 9,000 people died. Hundreds of monuments were damaged or collapsed, resulting in the cancelling of 32 per cent of tourist visits, a major GDP source. Following ODA pledges of US\$2.5 billion, Nepal's Government approved the rehabilitation of many but there are tensions between interpretations of Sendai's 'Build Back Better' framework and the preservation

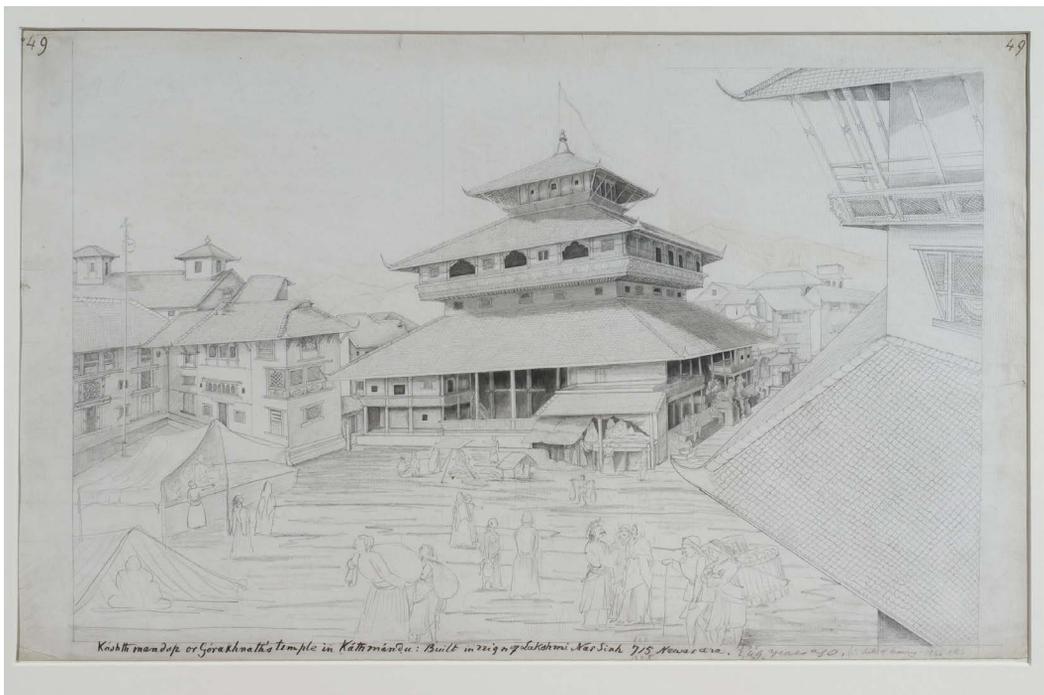
Figure 4. Drawing of the Kasthamandap by Raj Man Singh (1797–1865), collected by Brian Houghton Hodgson (1800–1894). (Image courtesy: Royal Asiatic Society (Acquisition Number 022.049))

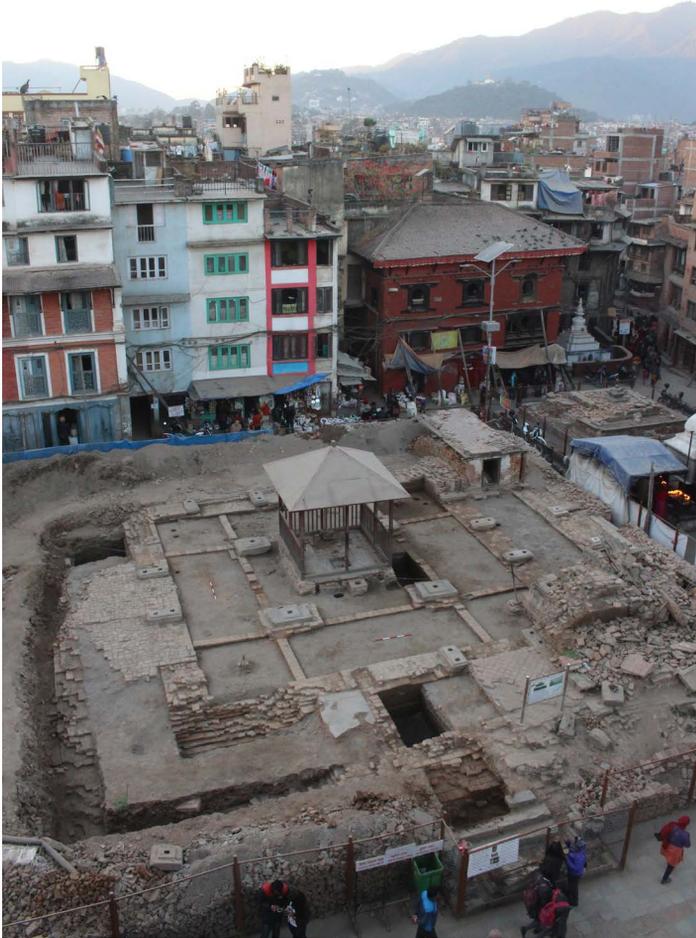
Figure 5. Uncovering the foundations, brick piers and later cross-walls, which formed a mandala, of the Kashtmandap during excavations in 2016. (Image: Durham UNESCO Chair)

The resulting pattern of foundation and bracing walls formed a nine-celled mandala, also found in other monuments within the Kathmandu Valley, such as at Harigaon (Verardi 1992). Our investigations of the central cell of the layout revealed the presence of another nine-celled mandala below the central sanctum. Furthermore, we recovered gold foil mandalas within the mortice sockets of each of the four central saddlestones, highlighting the intangible heritage associated with monumental construction in the Kathmandu Valley. Of symbolic value, the foundations and bracing walls clearly formed part of the seismic resilience of the Kasthamandap. Set in mud mortar, this material offered flexibility during seismic events and saved the building from greater stress. Originally constructed in *c.*700 CE, its foundations display remarkable resilience over centuries of earthquakes and our research has identified that the majority of damage caused to its foundations was caused during the emergency phase immediately after the 2015 Gorkha Earthquake but also that the monument had been weakened during earlier conservation interventions.

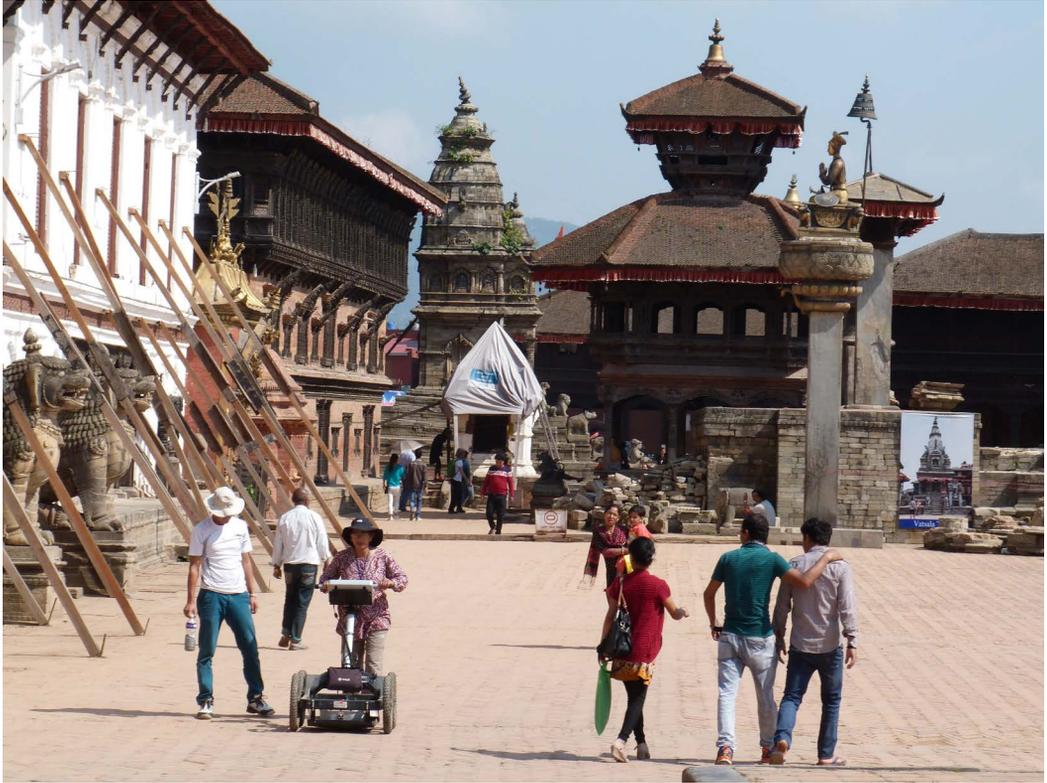
Figure 6. Ground Penetrating Radar survey across Bhaktapur Durbar Square in 2015. (Image: Durham UNESCO Chair)

number of historians that the school was built on top of a demolished part of the palace complex. The survey yielded anomalies around the area selected for the excavation trench and, just to the north of the volleyball field and south of the adjacent brick building, it identified the presence of a 3 metre wide row of rectangular ‘rooms’ at a depth of *c.*0.6 metres. Their location correlated with a step in the topography, probably caused by the linear brick structure beneath. Further south, running west to east through the middle of the volleyball field, a strong 2 metre wide anomaly was identified, probably the foundation of a substantial wall. It is pierced by a 4.4 metre wide opening that might have been a gate and, to east of the opening, there are some broadly rectangular cells, at a depth range of between 0.7 and 1.3 metres, are visible. These results, suggested that the community memory of the location of the long-lost palace was correct and but that this subsurface monument is vulnerable to redevelopment on the surface.

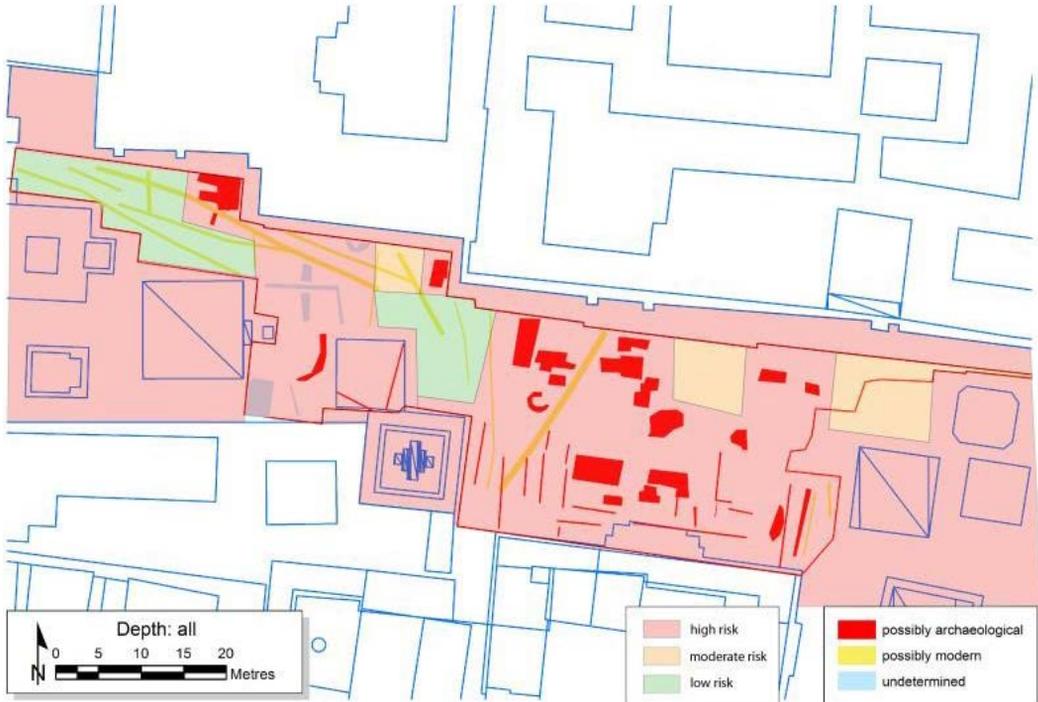
Figure 7. Provisional Risk Map for Bhaktapur Durbar Square based on results of excavation and Ground Penetrating Radar Survey. (Image: Armin Schmidt and Durham UNESCO Chair)

Our GPR surveys have led to the co-production of Archaeological Risk Maps to assist site managers guide development. This involved the generation of maps of potential subsurface features across Hanuman Dhoka, Patan and Bhaktapur within a traffic light system of Red, Yellow and Green—Red being associated with most risk to subsurface heritage and Green the lowest. The map of designated areas was accompanied by recommendations to help guide physical planning, facilitating the development of an awareness for the protection of subsurface heritage whilst not being of detriment to the rehabilitation of essential services (Figure 7). Current plans by the Asia Development Bank to cut a major sewer line through the World Heritage Monument core at Patan are currently being adjusted, based on these Archaeological Risk Maps, to ensure that the vulnerable subsurface heritage identified there will not be irreversible destroyed. Archaeological Risk Maps for the sites surveyed as part of the British Academy GCRF Cities and Infrastructure sponsored fieldwork are now being developed.

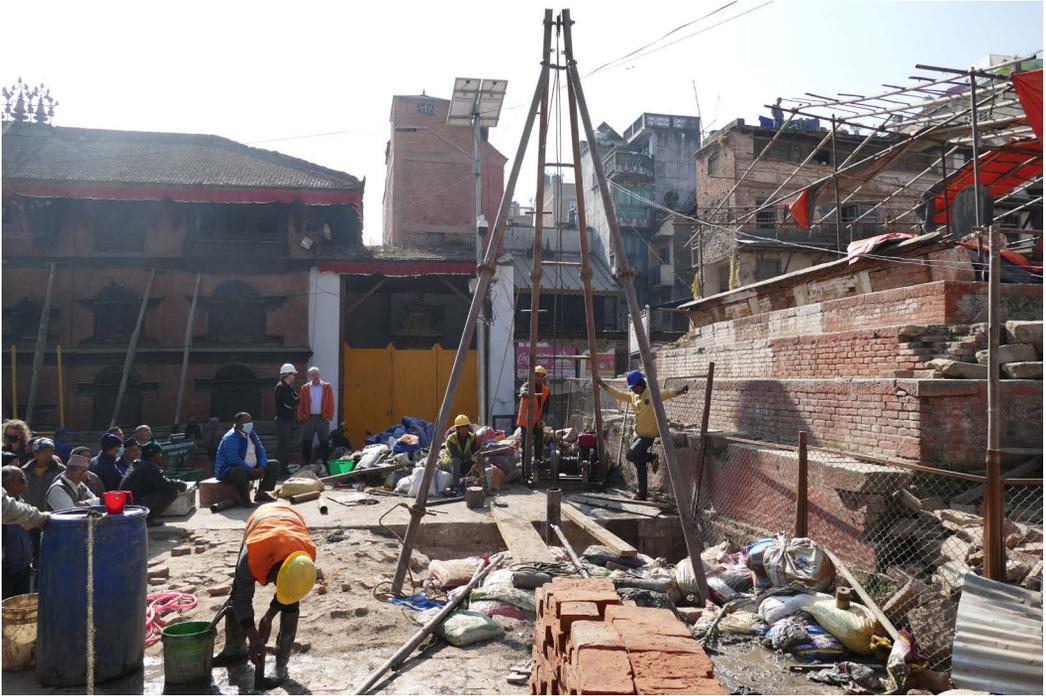
Figure 8. Borehole drilling being undertaken adjacent to the Trailokiya Mohan Temple, Hanuman Dhoka Durbar Square. (Image: Durham UNESCO Chair)

technique to be adopted to restore the affected structures. Both disturbed and undisturbed samples were collected at various depths from each borehole and transported to Durham for geotechnical testing. A total of thirty-one disturbed and eighteen undisturbed samples were collected from all the boreholes for characterisation and evaluation of engineering properties. Preliminary results indicate that the soil present at Pashupati and Changu Narayan may be categorised as site class D (stiff soil) whereas soils present at Bhaktapur, Trailokiya Mohan and Jaisidewal are under site class D (soft soil) as per the 2009 guidelines of the National Earthquakes Reduction Program (<https://www.nehrp.gov>). The presence of stiff soil lowers the chances of any wave amplification during an earthquake event for Pashupati and Changu Narayan; however, other sites might have experienced wave amplification and period elongation.

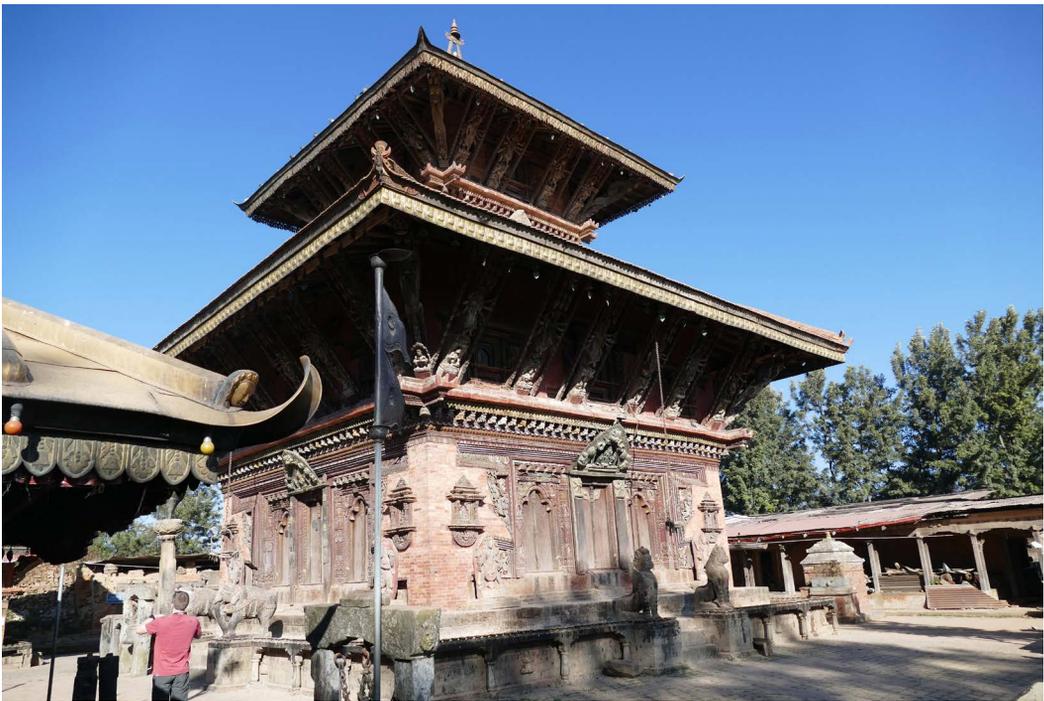
Figure 9. View of the main temple at Changu Narayan displaying symmetrical geometric configuration. (Image: Durham UNESCO Chair)

Symmetrical geometric configuration is the main feature of ancient structures surveyed in Kathmandu (Figure 9). Brick masonry walls act as a load-bearing system in these structures and wall thickness varies between walls on different stories. Inclined timber struts transfer the roof loads from tiled roofs to the masonry walls. In terms of seismic standpoint, masonry monuments and buildings are brittle structures in which mortar joints act as a plane of weakness. Experience has shown that masonry buildings are one of the most vulnerable of the entire building stock under strong earthquake shaking (Sarhosis *et al.* 2016). The large number of human fatalities in such constructions during past earthquakes corroborates this. Ground vibrations during earthquakes

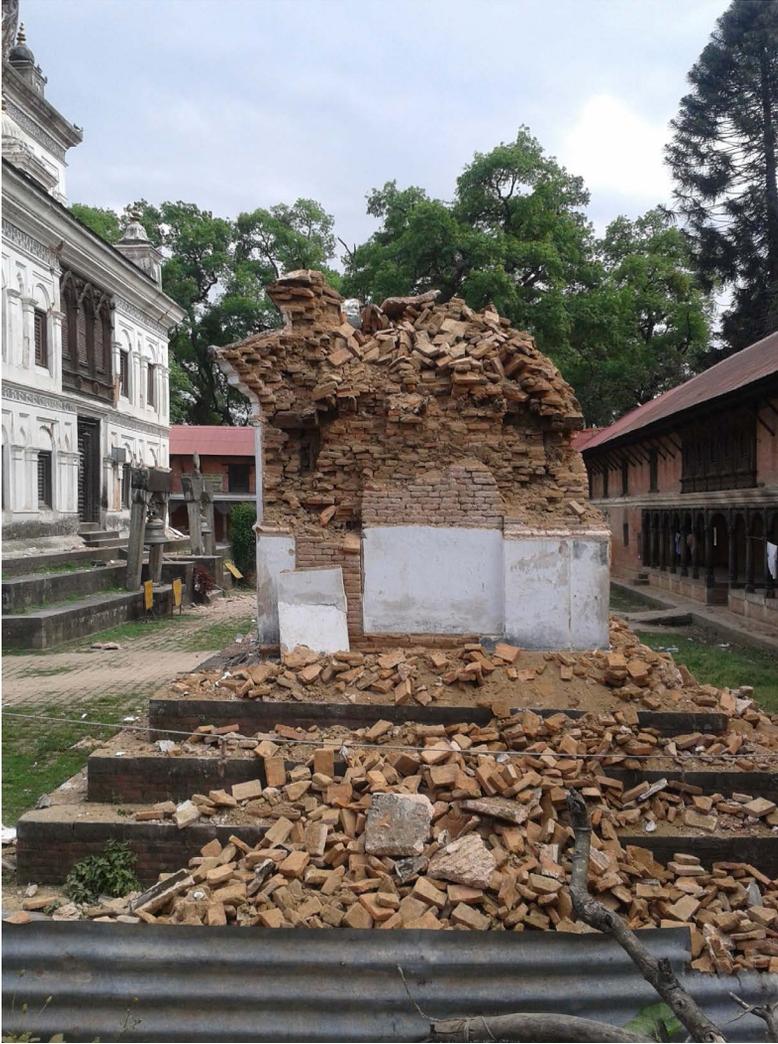
Figure 10. Brick shrine at Pashupati displaying complete masonry failure. (Image: Kai Weise)

That stone built temples at Pashupati did not exhibit such large crack patterns was evident from the fact that a stone-built temple was observed to be intact as compared to a temple constructed of brick masonry located less than 30 metres away (Figure 10). This was probably due to the fact that small temples developed good box action between all the elements of the building and in particular that of the roof and walls. Similar crack patterns were identified in many temples with similar geometrical configurations also constructed using brick masonry walls. This damage pattern is attributed to stress concentration near the crown portion of the temples and their inability to bear bending stress induced during seismic shaking. The possibility of rotation and differential settlements in the foundation components of these structures were also explored during the reconnaissance survey. At present, restoration works

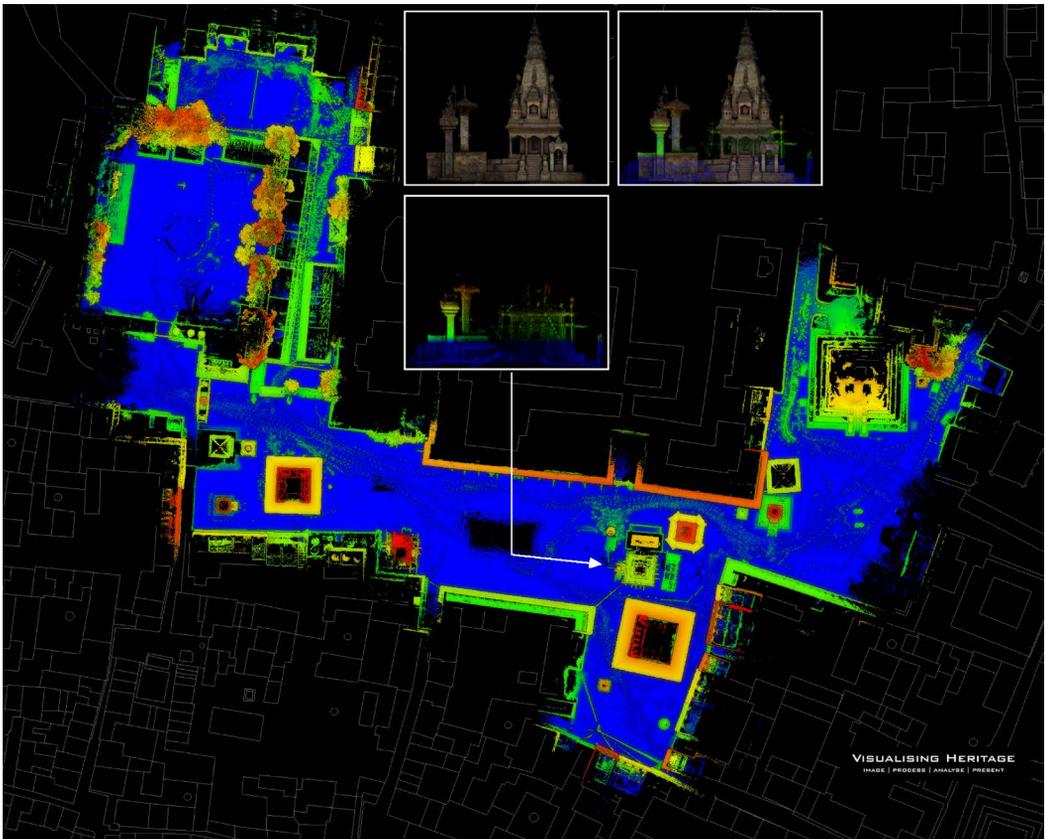
Figure 11. Web-scraped image data for Bhaktapur's Durbar Square, Kathmandu, Nepal was combined with Zeb-Revo. RT data shaded. (Image: Bradford University)

processed to produce meshed and textured models. Our downloaded images, database files and processed data add up to around 2.8TB of data and we are already able to present historic urban cityscapes which no longer exist (Figures 11 and 12).
